# Why you need a FLUKE ACOUSTIC IMAGER

for your conveyor system maintenance

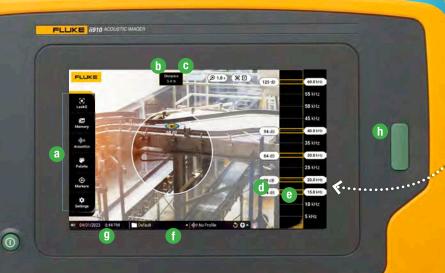
2 Large 7" touch screen

High resolution 7" capacitive, full color touch screen with outstanding view ability, supports interaction with interface menu.

- a Tool menu
- Distance indication
- On display Leak or PD quantification
- d Palette of dB SPL Scale
- Frequency spectrum
- f Folder selection
- g Battery status and date
- h One button capture image
